**Flood Control Project Maintenance
Levee Inspections**
LMA District Cover Sheet
Spring 2018 Levee Inspection Results

Sacramento Maintenance Yard Maintenance Area 0009

Spring 2018 Levee Inspection Results

Waterway	Bank	Unit Miles
Unit No. 01 Sacramento River	Left	19.35

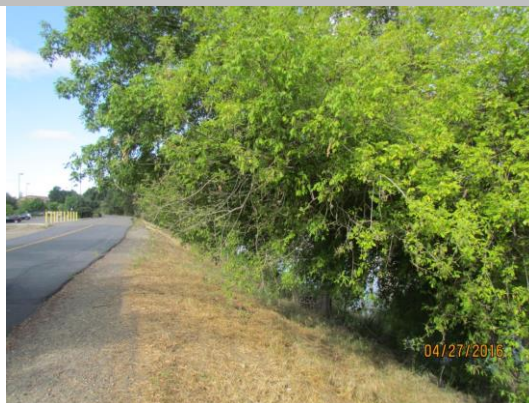
Photo 1 of 1 : SP_2018_MA0009_201_286_20180306_00225.jpg

LM Start	0.37	Rating **	M	Issue No.	286
LM End	0.37	Issue Type +	Ma	Location *	WS
Category	Earthen Levee			GPS Latitude/Longitude	
				Start	End
Item	Trim / Thin Trees			38.536875 °	38.536875 °
				-121.515533 °	-121.515533 °
DWR ID	DWR_MA0009_01_s_2016_286				
Comment Code					
T1 : Trim trees to at least five feet above ground level.					
Inspector Comment

View of the trees on the waterward side of the levee looking downstream. Spring 2016.

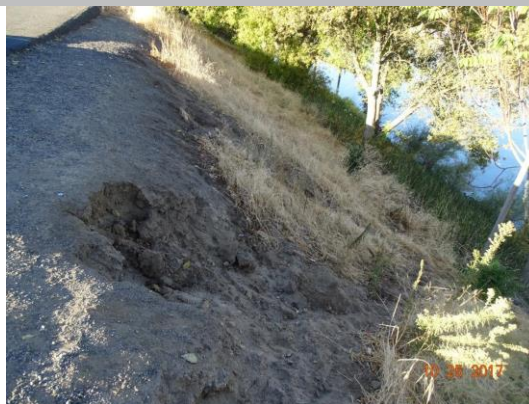
Photo 1 of 1 : SP_2018_MA0009_201_298_20180306_00233.jpg

LM Start	0.38	Rating **	M	Issue No.	298
LM End	0.38	Issue Type +	Ma	Location *	WS
Category	Earthen Levee			GPS Latitude/Longitude	
				Start	End
Item	Erosion / Bank Caving			38.536712 °	38.536712 °
				-121.515757 °	-121.515757 °
DWR ID	DWR_MA0009_01_f_2017_298				
Comment Code					
E2 : Schedule repair of erosion site prior to the next inspection.					
Inspector Comment					
Footpath that is beginning to erode further from runoff.

View of erosion on waterside slope. Fall 2017.

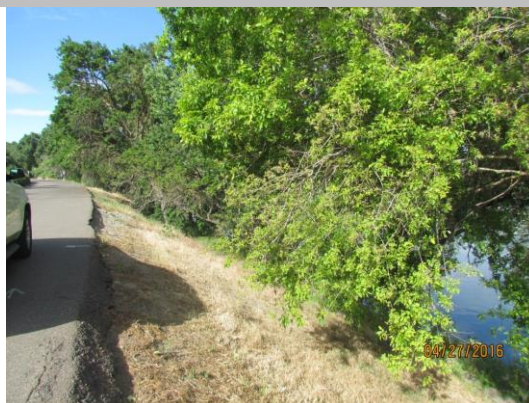
Photo 1 of 1 : SP_2018_MA0009_201_281_20180306_00220.jpg

LM Start	0.40	Rating **	M	Issue No.	281
LM End	0.40	Issue Type +	Ma	Location *	WS
Category	Earthen Levee			GPS Latitude/Longitude	
				Start	End
Item	Trim / Thin Trees			38.536556 °	38.536556 °
				-121.515990 °	-121.515990 °
DWR ID	DWR_MA0009_01_f_2015_281				
Comment Code					
T1 : Trim trees to at least five feet above ground level.					
Inspector Comment

View of the trees on the waterward side of the levee looking downstream. Spring 2016.

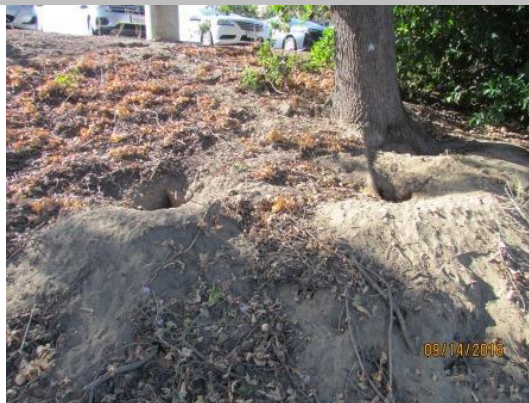
Photo 2 of 4 : SP_2018_MA0009_201_282_20180306_00222.jpg

LM Start	0.53	Rating **	M	Issue No.	282 (cont)
LM End	0.53	Issue Type +	Ma	Location *	WS

View of rodent holes on the waterside slope of the levee. Fall 2016

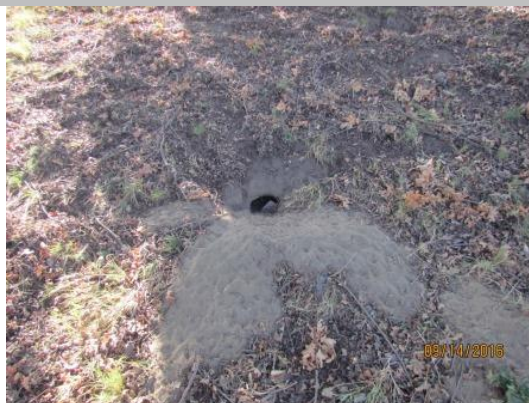
Photo 3 of 4 : SP_2018_MA0009_201_282_20180306_00223.jpg

View of the rodent holes on waterside of the levee.

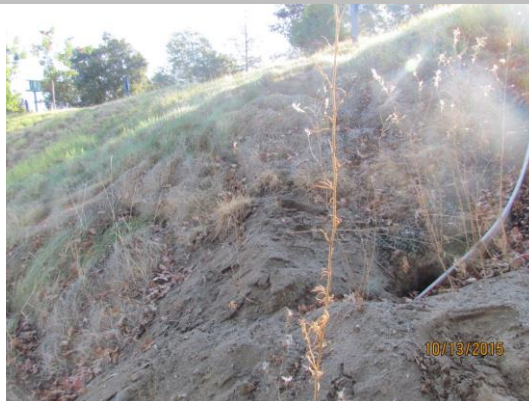
Photo 4 of 4 : SP_2018_MA0009_201_282_20180306_00224.jpg

LM Start	0.53	Rating **	M	Issue No.	282 (cont)
LM End	0.53	Issue Type +	Ma	Location *	WS

View of the rodent hole on the waterward side of the levee. Fall 2015.

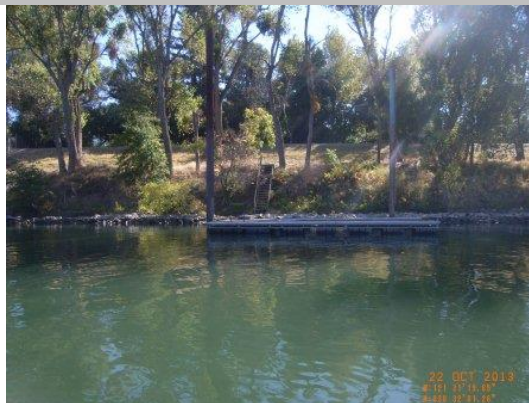
Photo 2 of 2 : SP_2018_MA0009_201_8_20180306_00009.jpg

LM Start	0.70	Rating **	M	Issue No.	8 (cont)	
LM End	0.86	Issue Type +	Ma	Location *	WS	
Category	Supplemental			GPS Latitude/Longitude		
				Start		End
Item	2015 USACE Erosion Survey, DRAFT			38.534144 °		38.533143 °
				-121.520263 °		-121.523010 °
DWR ID	DWR_MA0009_01_s_2018_8					
Comment Code						
Inspector Comment						
Site previously named 55.1. 2003 - Pockets of toe erosion at low flow waterline. 2005 - Site renamed 55.2. Still have pockets of erosion but rock bench at waterline is still present. 2010 - Site extended upstream due to new erosion. 2011 - Some of the toe rock has failed. The upper levee slope seems to be slumping. 2012 - Minor new slumping. 2015: No observed changes. [2015 Site ID: SAC_55-2_L]

USACE 2013 Photo #2

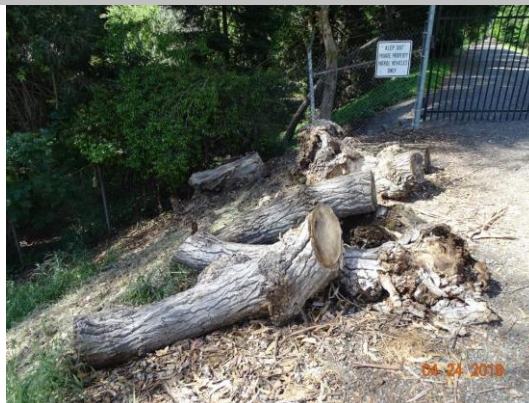
Photo 1 of 1 : SP_2018_MA0009_201_302_20180425_00520.jpg

LM Start	0.78	Rating **	M	Issue No.	302	
LM End	0.78	Issue Type +	Ma	Location *	CR	
Category	Earthen Levee			GPS Latitude/Longitude		
				Start		End
Item	Encroachments			38.533406 °		38.533406 °
				-121.521463 °		-121.521463 °
DWR ID	DWR_MA0009_01_f_2017_302					
Comment Code						
TR : Tree or limb						
Inspector Comment

View of limbs on the crown. Spring 2018.

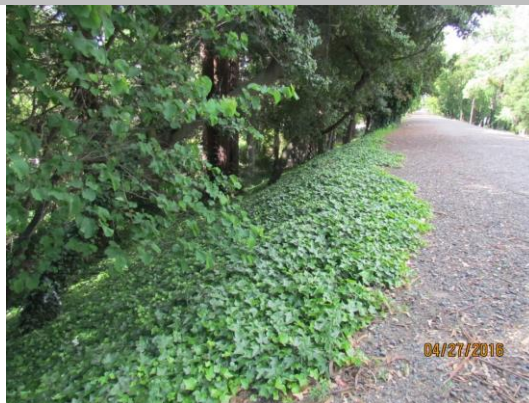
Photo 1 of 1 : SP_2018_MA0009_201_10_20180306_00010.jpg

LM Start	0.79	Rating **	M	Issue No.	10
LM End	0.81	Issue Type +	En	Location *	LS
Category	Earthen Levee			GPS Latitude/Longitude	
				Start	End
Item	Vegetation			38.533348 °	38.533207 °
				-121.521576 °	-121.521916 °
DWR ID	DWR_MA0009_01_f_2016_10				
Comment Code					
V6 : Landscaping					
Inspector Comment					
Fence and trees are permitted by Permit 12394, but groundcover is not. Groundcover obstructs visibility.

View of the vegetation on the landward side of the levee looking downstream. Spring 2016.

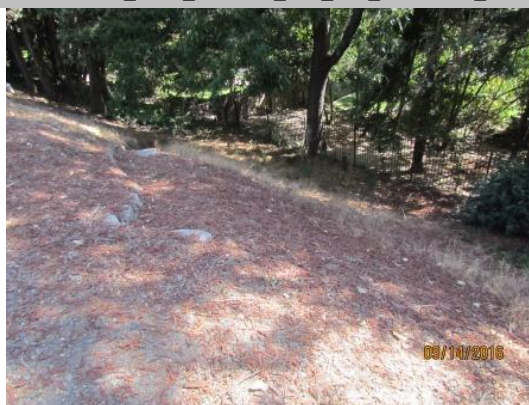
Photo 1 of 1 : SP_2018_MA0009_201_242_20180306_00189.jpg

LM Start	0.83	Rating **	M	Issue No.	242
LM End	0.83	Issue Type +	En	Location *	LS
Category	Earthen Levee			GPS Latitude/Longitude	
				Start	End
Item	Encroachments			38.533056 °	38.533056 °
				-121.522339 °	-121.522339 °
DWR ID	DWR_MA0009_01_f_2016_242				
Comment Code					
ST : Stairway					
Inspector Comment

Old footpath on landside slope of the levee. Fall 2016 inspection.

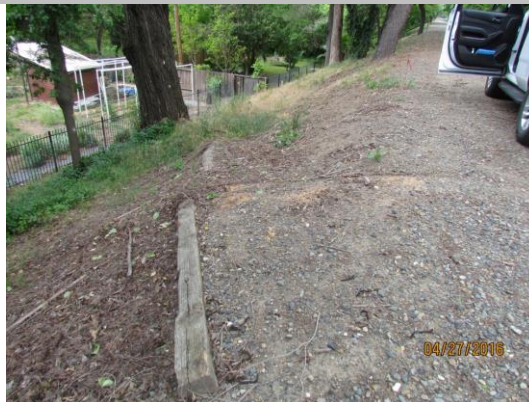
Photo 1 of 1 : SP_2018_MA0009_201_13_20180306_00011.jpg

LM Start	0.85	Rating **	M	Issue No.	13
LM End	0.85	Issue Type +	En	Location *	LS
Category	Earthen Levee			GPS Latitude/Longitude	
				Start	End
Item	Encroachments			38.532945 °	38.532920 °
				-121.522570 °	-121.522648 °
DWR ID	DWR_MA0009_01_s_2012_13				
Comment Code					
ST : Stairway					
Inspector Comment

View of the Footpath that cuts into the levee slope on the landward side looking downstream. Spring 2016.

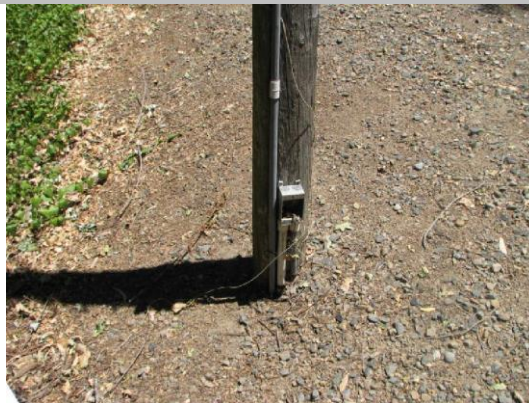
FS_ID:41534
DS_ID:17407
EP_NO: N/A
Repair Type: Non-Urgent
Crossing Status: Found
UCIP Comments: Appears abandoned.
FIELD_STRUCT_DESC: 1.5-inch electrical conduit of an unknown material through the levee, at an unknown depth. Pole on the waterside (WS) slope. [Additional Reference(s): DWR Levee Log, 1991].
FS Date: 6/19/2012 7:58:00 AM

Electrical conduit at bottom of pole on water side.

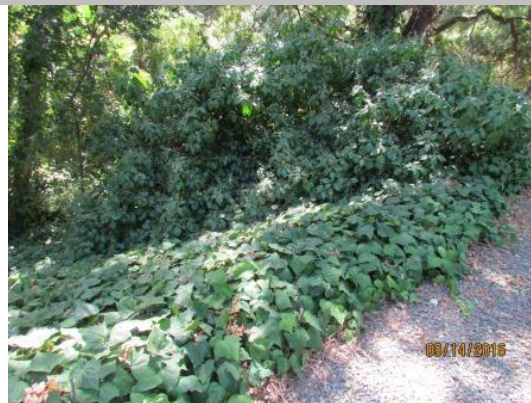
Photo 1 of 2 : SP_2018_MA0009_201_15_20180306_00012.jpg

LM Start	0.88	Rating **	U	Issue No.	15
LM End	0.90	Issue Type +	En	Location *	LS
Category	Earthen Levee			GPS Latitude/Longitude	
				Start	End
Item	Vegetation			38.532730 °	38.532628 °
				-121.523129 °	-121.523406 °
DWR ID	DWR_MA0009_01_s_2012_15				
Comment Code					
V6 : Landscaping					
Inspector Comment					
Permit 16347 covers the English ivy groundcover and five ornamental trees on the landside. Trees are obstructing view and need to be trimmed.

Groundcover on landside slope. Fall 2016 inspection.

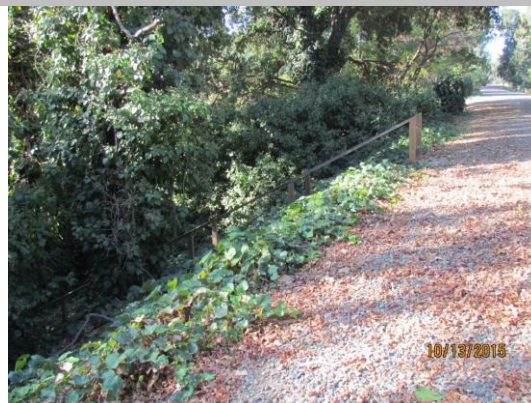
Photo 2 of 2 : SP_2018_MA0009_201_15_20180306_00013.jpg

LM Start	0.88	Rating **	U	Issue No.	15 (cont)
LM End	0.90	Issue Type +	En	Location *	LS

View of the groundcover and trees on the landward side of the levee looking downstream. Fall 2015.

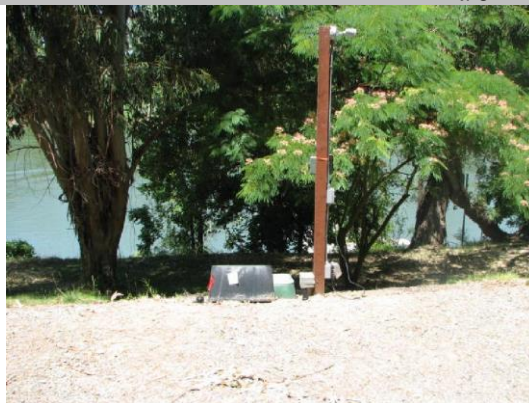
Photo 3 of 3 : UCIP_SP_2018_5844_8912.jpg

LM Start	0.98	Rating **	M	Issue No.	1776 (cont)	
LM End	0.98	Issue Type +	En	Location *		
Category	Supplemental			GPS Latitude/Longitude		
				Start	End	
Item	DWR UCIP Field Study			38.532150 °	38.532150 °	
				-121.524660 °	-121.524660 °	
DWR ID						
Comment Code						
Inspector Comment						
FS_ID:5844 DS_ID:18897 EP_NO: N/A Repair Type: Non-Urgent Crossing Status: Found UCIP Comments: No permit identified for this crossing. FIELD_STRUCT_DESC: 1-inch polyvinyl chloride (PVC) electrical conduit through the levee, 1.5 feet below the crown. Light on pole next to irrigation box on the waterside (WS) shoulder. FS Date: 6/19/2012 9:30:37 AM

Light on Pole WS slope.

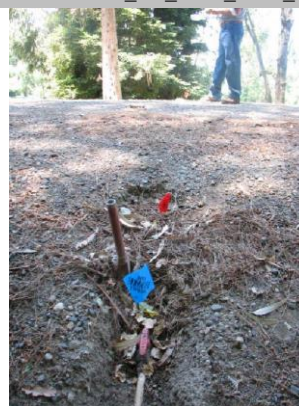
Photo 1 of 1 : UCIP_SP_2018_5846_8917.jpg

LM Start	0.99	Rating **	M	Issue No.	1778
LM End	0.99	Issue Type +	En	Location *	
Category	Supplemental			GPS Latitude/Longitude	
				Start	End
Item	DWR UCIP Field Study			38.532070 °	38.532070 °
				-121.524950 °	-121.524950 °
DWR ID					
Comment Code					
Inspector Comment					
FS_ID:5846 DS_ID:18900 EP_NO: N/A Repair Type: Non-Urgent Crossing Status: Found UCIP Comments: No permit identified for this crossing. FIELD_STRUCT_DESC: 1-inch polyvinyl chloride (PVC) water line through the levee, 1.5 feet below the crown. Shutoff valve on the landside (LS) shoulder. FS Date: 6/19/2012 9:36:43 AM

View of pipe and valve on LS shoulder looking towards WS slope.

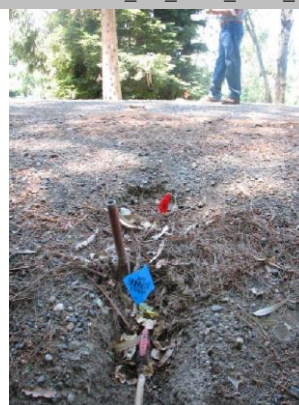
Photo 1 of 1 : UCIP_SP_2018_5847_8918.jpg

LM Start	0.99	Rating **	M	Issue No.	1779
LM End	0.99	Issue Type +	En	Location *	
Category	Supplemental			GPS Latitude/Longitude	
				Start	End
Item	DWR UCIP Field Study			38.532050 °	38.532050 °
				-121.524940 °	-121.524940 °
DWR ID					
Comment Code					
Inspector Comment					
FS_ID:5847 DS_ID:18901 EP_NO: N/A Repair Type: Non-Urgent Crossing Status: Found UCIP Comments: No permit identified for this crossing. FIELD_STRUCT_DESC: 1-inch polyvinyl chloride (PVC) electrical conduit through the levee, 1.5 feet below the crown. Shutoff valve on the landside (LS) shoulder. FS Date: 6/19/2012 9:39:42 AM

Pipes visible on LS shoulder/slope looking towards WS.

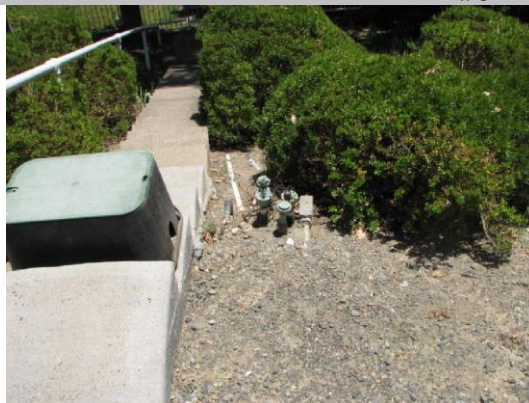
Photo 3 of 3 : UCIP_SP_2018_5848_8919.jpg

LM Start	1.01	Rating **	M	Issue No.	1780 (cont)	
LM End	1.01	Issue Type +	En	Location *		
Category	Supplemental			GPS Latitude/Longitude		
				Start	End	
Item	DWR UCIP Field Study			38.531970 °	38.531970 °	
				-121.525210 °	-121.525210 °	
DWR ID						
Comment Code						
Inspector Comment						
FS_ID:5848 DS_ID:18903 EP_NO: N/A Repair Type: Non-Urgent Crossing Status: Found UCIP Comments: No permit identified for this crossing. FIELD_STRUCT_DESC: 0.75-inch polyvinyl chloride (PVC) water line through the levee, 1.5 feet below the crown. Hose bib and electrical box visible on the waterside (WS) shoulder. Pipe visible on the downstream side of the landside (LS) shoulder stairs. (Permit No. 6293, 1968 - William H. Geyer). FS Date: 6/19/2012 9:42:01 AM

Pipes on LS slope 1-foot downstream from concrete stairs.

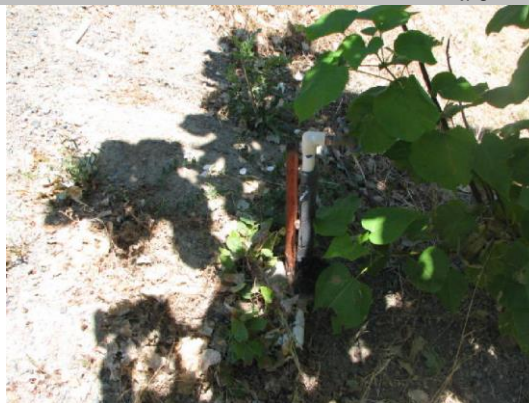
Photo 1 of 3 : UCIP_SP_2018_5850_8926.jpg

LM Start	1.02	Rating **	M	Issue No.	1782	
LM End	1.02	Issue Type +	En	Location *		
Category	Supplemental			GPS Latitude/Longitude		
				Start	End	
Item	DWR UCIP Field Study			38.531880 °	38.531880 °	
				-121.525470 °	-121.525470 °	
DWR ID						
Comment Code						
Inspector Comment						
FS_ID:5850 DS_ID:18904 EP_NO: N/A Repair Type: Non-Urgent Crossing Status: Found UCIP Comments: No permit identified for this crossing. FIELD_STRUCT_DESC: 1-inch polyvinyl chloride (PVC) water line through the levee, 1.5 feet below the crown. Hose bibs on both the waterside (WS) and the landside (LS) shoulders. T posts mark end of line on both sides of the levee. FS Date: 6/19/2012 9:47:29 AM

Hose bib and T-post on LS slope 3-feet upstream of concrete stairs.

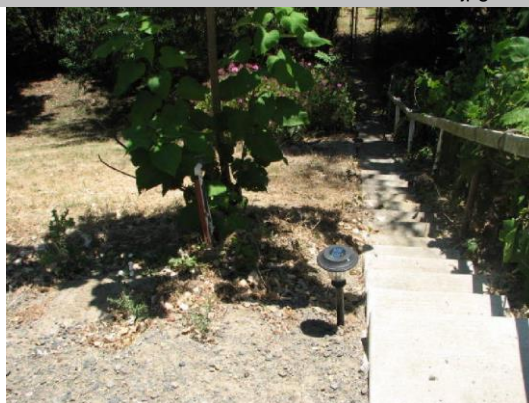
Photo 2 of 3 : UCIP_SP_2018_5850_8925.jpg

LM Start	1.02	Rating **	M	Issue No.	1782 (cont)
LM End	1.02	Issue Type +	En	Location *

Hosebib on LS slope.

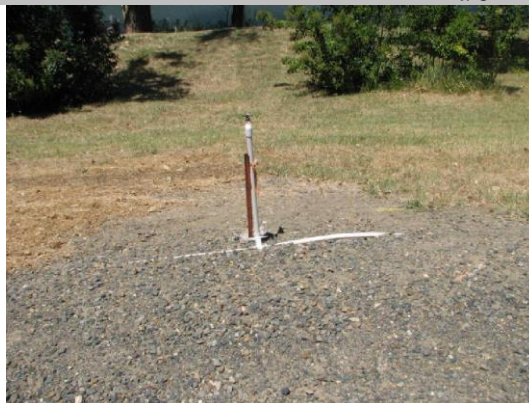
Photo 3 of 3 : UCIP_SP_2018_5850_8924.jpg

LM Start	1.02	Rating **	M	Issue No.	1782 (cont)	
LM End	1.02	Issue Type +	En	Location *		
Category	Supplemental			GPS Latitude/Longitude		
				Start	End	
Item	DWR UCIP Field Study			38.531880 °	38.531880 °	
				-121.525470 °	-121.525470 °	
DWR ID						
Comment Code						
Inspector Comment						
FS_ID:5850 DS_ID:18904 EP_NO: N/A Repair Type: Non-Urgent Crossing Status: Found UCIP Comments: No permit identified for this crossing. FIELD_STRUCT_DESC: 1-inch polyvinyl chloride (PVC) water line through the levee, 1.5 feet below the crown. Hose bibs on both the waterside (WS) and the landside (LS) shoulders. T posts mark end of line on both sides of the levee. FS Date: 6/19/2012 9:47:29 AM

Hosebib on WS slope.

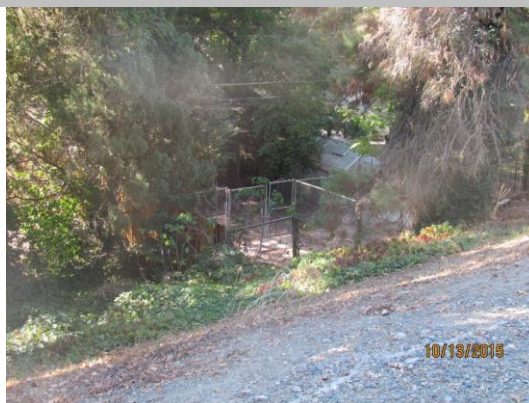
Photo 1 of 2 : SP_2018_MA0009_201_28_20180306_00020.jpg

LM Start	1.02	Rating **	M	Issue No.	28
LM End	1.04	Issue Type +	En	Location *	LS
Category	Earthen Levee			GPS Latitude/Longitude	
				Start	End
Item	Vegetation			38.531853 °	38.531755 °
				-121.525512 °	-121.525794 °
DWR ID	DWR_MA0009_01_s_2012_28				
Comment Code					
V6 : Landscaping					
Inspector Comment					
Permit 16352 covers wooden steps, an irrigation system, six ornamental trees and ground cover. Trees need to be trimmed.

View of the landscaping on the landward side of the levee. Fall 2015.

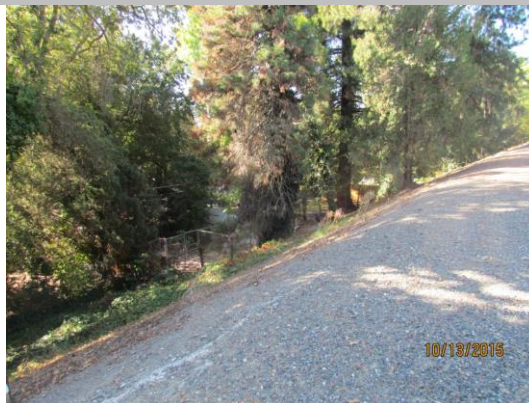
Photo 2 of 2 : SP_2018_MA0009_201_28_20180306_00021.jpg

LM Start	1.02	Rating **	M	Issue No.	28 (cont)
LM End	1.04	Issue Type +	En	Location *	LS
Category	Earthen Levee			GPS Latitude/Longitude	
				Start	End
Item	Vegetation			38.531853 °	38.531755 °
				-121.525512 °	-121.525794 °
DWR ID	DWR_MA0009_01_s_2012_28				
Comment Code					
V6 : Landscaping					
Inspector Comment					
Permit 16352 covers wooden steps, an irrigation system, six ornamental trees and ground cover. Trees need to be trimmed.

Perspective view of the vegetation on the landward side of the levee looking downstream. Fall 2015.

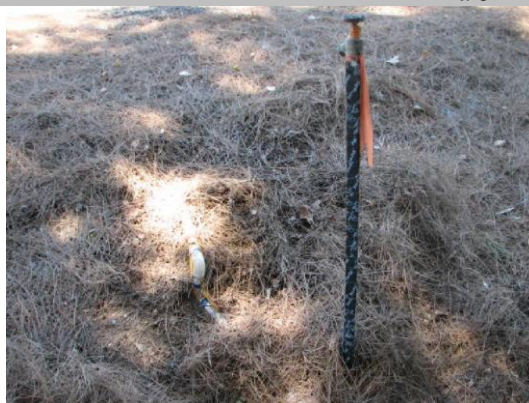
Photo 1 of 3 : UCIP_SP_2018_5851_8929.jpg

LM Start	1.04	Rating **	M	Issue No.	1783
LM End	1.04	Issue Type +	En	Location *	
Category	Supplemental			GPS Latitude/Longitude	
				Start	End
Item	DWR UCIP Field Study			38.531750 °	38.531750 °
				-121.525810 °	-121.525810 °
DWR ID					
Comment Code					
Inspector Comment					
FS_ID:5851					
DS_ID:18905					
EP_NO: N/A					
Repair Type: Non-Urgent					
Crossing Status: Found					
UCIP Comments: No permit identified for this crossing. Pipe open on WS slope.					
FIELD_STRUCT_DESC: 0.75-inch polyvinyl chloride (PVC) water line through the levee, 1.5 feet below the crown. Hose bib on the landside (LS) shoulder.					
FS Date: 6/19/2012 9:50:50 AM

Hosebib on LS slope.

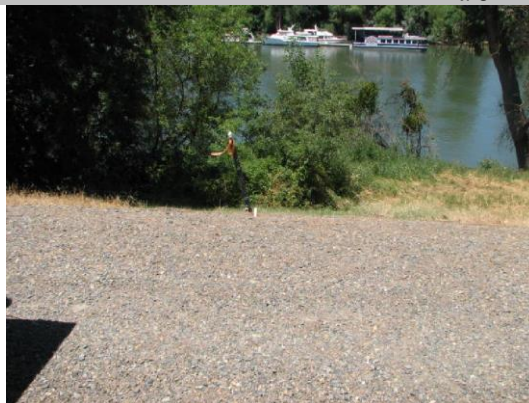
Photo 2 of 3 : UCIP_SP_2018_5851_8928.jpg

LM Start	1.04	Rating **	M	Issue No.	1783 (cont)	
LM End	1.04	Issue Type +	En	Location *		
Category	Supplemental			GPS Latitude/Longitude		
				Start	End	
Item	DWR UCIP Field Study			38.531750 °	38.531750 °	
				-121.525810 °	-121.525810 °	
DWR ID						
Comment Code						
Inspector Comment						
FS_ID:5851 DS_ID:18905 EP_NO: N/A Repair Type: Non-Urgent Crossing Status: Found UCIP Comments: No permit identified for this crossing. Pipe open on WS slope. FIELD_STRUCT_DESC: 0.75-inch polyvinyl chloride (PVC) water line through the levee, 1.5 feet below the crown. Hose bib on the landside (LS) shoulder. FS Date: 6/19/2012 9:50:50 AM

Hosebib on WS slope.

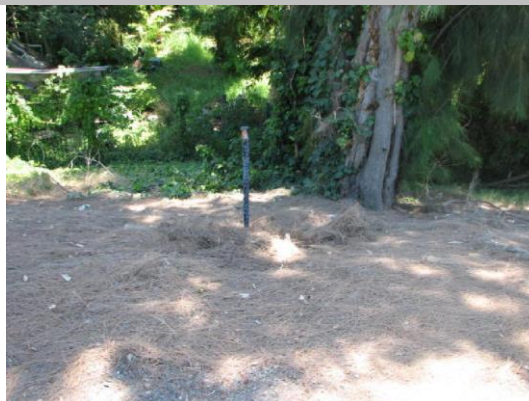
Photo 3 of 3 : UCIP_SP_2018_5851_8927.jpg

LM Start	1.04	Rating **	M	Issue No.	1783 (cont)
LM End	1.04	Issue Type +	En	Location *

Hosebib on LS slope.

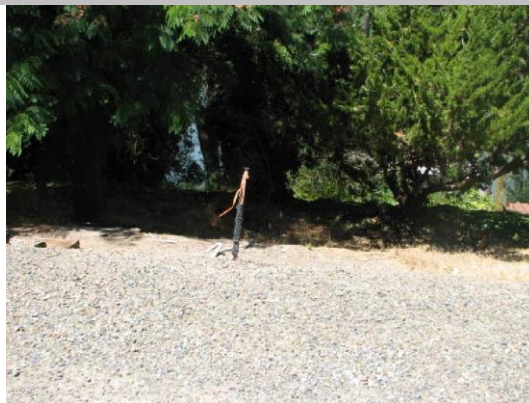
Photo 2 of 2 : UCIP_SP_2018_5852_8931.jpg

LM Start	1.06	Rating **	M	Issue No.	1784 (cont)
LM End	1.06	Issue Type +	En	Location *

Hose bib on WS shoulder.

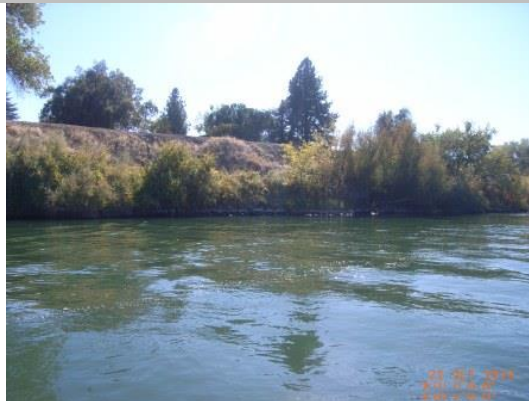
Photo 1 of 2 : SP_2018_MA0009_201_3_20180306_00002.jpg

LM Start	1.08	Rating **	M	Issue No.	3
LM End	1.14	Issue Type +	Ma	Location *	WS
Category	Supplemental			GPS Latitude/Longitude	
				Start	End
Item	2015 USACE Erosion Survey, DRAFT			38.531806 °	38.531417 °
				-121.526566 °	-121.527589 °
DWR ID	DWR_MA0009_01_s_2016_3				
Comment Code					
Inspector Comment					
2011 - A large tree has fallen behind a larger tree, putting stress on an already compromised tree. Toe erosion due to wave wash. 2013 - Site extended upstream due to steep bank. 2015: Site extended upstream due to steep bank. [2015 Site ID: SAC_54-8_L]

USACE 2013 Photo #1

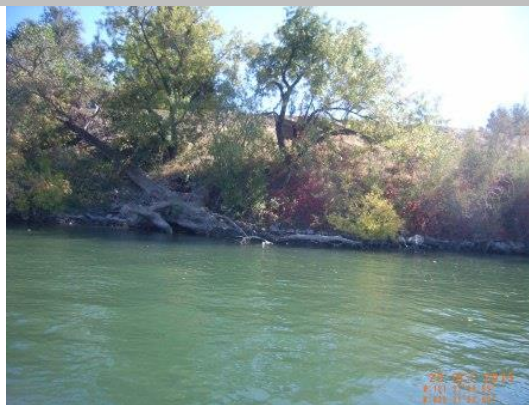
Photo 2 of 2 : SP_2018_MA0009_201_3_20180306_00003.jpg

LM Start	1.08	Rating **	M	Issue No.	3 (cont)
LM End	1.14	Issue Type +	Ma	Location *	WS

USACE 2013 Photo #2

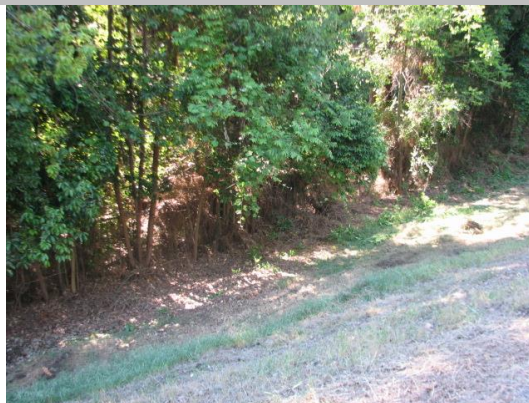
Photo 2 of 2 : SP_2018_MA0009_201_33_20180306_00023.jpg

LM Start	1.26	Rating **	M	Issue No.	33 (cont)	
LM End	1.29	Issue Type +	En	Location *	LS	
Category	Earthen Levee			GPS Latitude/Longitude		
				Start		End
Item	Vegetation			38.529952 °		38.529420 °
				-121.528770 °		-121.528905 °
DWR ID	DWR_MA0009_01_s_2012_33					
Comment Code						
V6 : Landscaping						
Inspector Comment						
Fence has been permitted by Permit 16410. Trees need to be trimmed for visibility.

The owner has made great progress with the vegetation. Vegetation still blocks visibility. Spring 2014

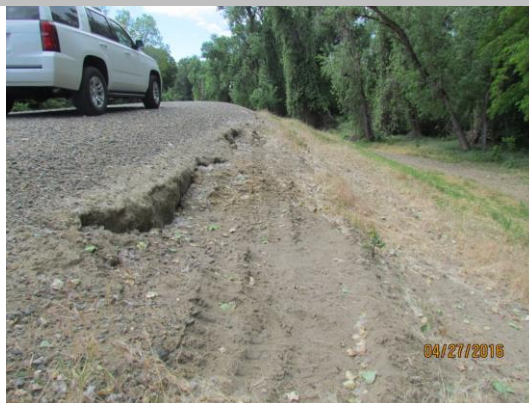
Photo 2 of 2 : SP_2018_MA0009_201_312_20180306_00248.jpg

LM Start	1.27	Rating **	M	Issue No.	312
LM End	1.28	Issue Type +	Ma	Location *	WS
Category	Earthen Levee			GPS Latitude/Longitude	
				Start	End
Item	Erosion / Bank Caving			38.529798 °	38.529679 °
				-121.528808 °	-121.528858 °
DWR ID	DWR_MA0009_01_f_2015_312				
Comment Code					
E2 : Schedule repair of erosion site prior to the next inspection.					
Inspector Comment					
Repair erosion on WS of the levee.

LM Start	1.27	Rating **	M	Issue No.	312 (cont)
LM End	1.28	Issue Type +	Ma	Location *	WS

View of the erosion on the waterward side of the levee looking downstream. Erosion is on below the shoulder of the levee. Spring 2016.

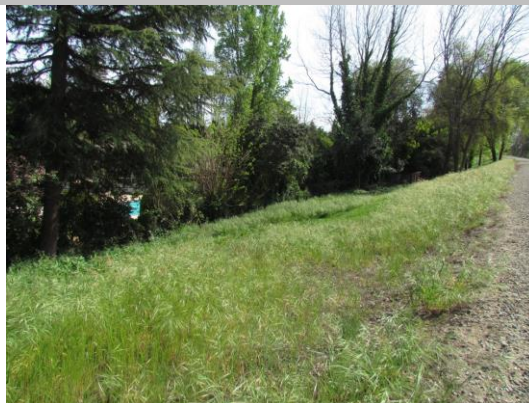
Photo 1 of 1 : SP_2018_MA0009_201_34_20180306_00024.jpg

LM Start	1.29	Rating **	M	Issue No.	34
LM End	1.33	Issue Type +	En	Location *	LS
Category	Earthen Levee			GPS Latitude/Longitude	
				Start	End
Item	Vegetation			38.529468 °	38.528930 °
				-121.528823 °	-121.528820 °
DWR ID	DWR_MA0009_01_s_2012_34				
Comment Code					
V6 : Landscaping					
Inspector Comment					
Fence is permitted through Permit 16354. Trees need to be thinned and trimmed for visibility.

View of vegetation on the landward side of the levee looking downstream. Spring 2015.

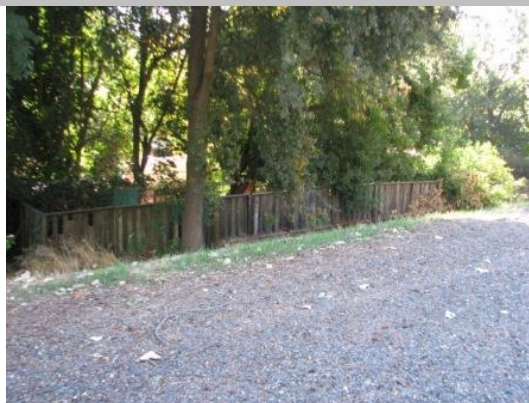
Photo 1 of 1 : SP_2018_MA0009_201_36_20180306_00025.jpg

LM Start	1.33	Rating **	M	Issue No.	36
LM End	1.34	Issue Type +	En	Location *	LS
Category	Earthen Levee			GPS Latitude/Longitude	
				Start	End
Item	Encroachments			38.528913 °	38.528727 °
				-121.528818 °	-121.528809 °
DWR ID	DWR_MA0009_01_s_2012_36				
Comment Code					
FE : Fence					
Inspector Comment

A wooden fence is within the easement of the levee. Fall 2013

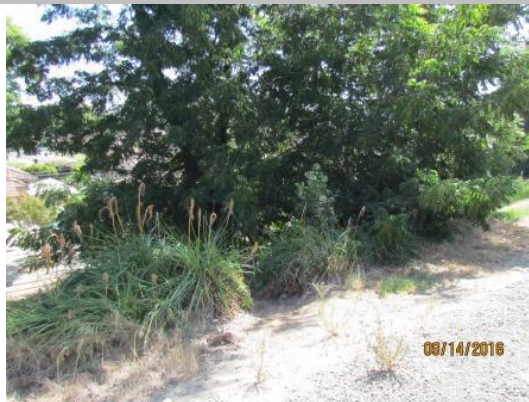
Photo 1 of 2 : SP_2018_MA0009_201_241_20180306_00187.jpg

LM Start	1.37	Rating **	M	Issue No.	241
LM End	1.37	Issue Type +	En	Location *	LS
Category	Earthen Levee			GPS Latitude/Longitude	
				Start	End
Item	Vegetation			38.528255 °	38.528255 °
				-121.528800 °	-121.528800 °
DWR ID	DWR_MA0009_01_f_2016_241				
Comment Code					
V6 : Landscaping					
Inspector Comment

Irrigation system provides water to vegetation on landside slope. Fall 2016 inspection. Another view.

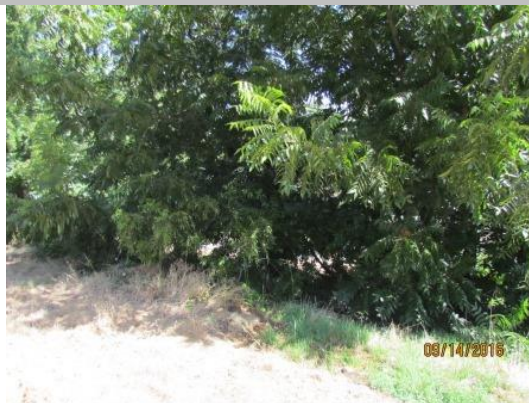
Photo 2 of 2 : SP_2018_MA0009_201_241_20180306_00188.jpg

LM Start	1.37	Rating **	M	Issue No.	241 (cont)	
LM End	1.37	Issue Type +	En	Location *	LS	
Category	Earthen Levee			GPS Latitude/Longitude		
				Start		End
Item	Vegetation			38.528255 °		38.528255 °
				-121.528800 °		-121.528800 °
DWR ID	DWR_MA0009_01_f_2016_241					
Comment Code						
V6 : Landscaping						
Inspector Comment

Irrigation system provides water to vegetation on landside slope. Fall 2016 inspection.

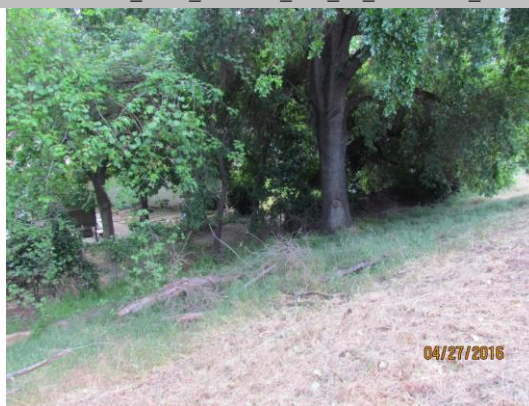
Photo 2 of 2 : SP_2018_MA0009_201_22_20180306_00019.jpg

LM Start	1.48	Rating **	A/W	Issue No.	22 (cont)	
LM End	1.48	Issue Type +	En	Location *	LS	
Category	Earthen Levee			GPS Latitude/Longitude		
				Start		End
Item	Vegetation			38.526787 °		38.526787 °
				-121.528096 °		-121.528096 °
DWR ID	DWR_MA0009_01_f_2012_22					
Comment Code						
V6 : Landscaping						
Inspector Comment						
Fence is permitted by Permit 7474. Fence seems to be cleared of vegetation but vines are still present on the fence.

View of the fence and vegetation on the landward side of the levee looking downstream. Vegetation on the fence is gone but may grow back given time. Spring 2016.

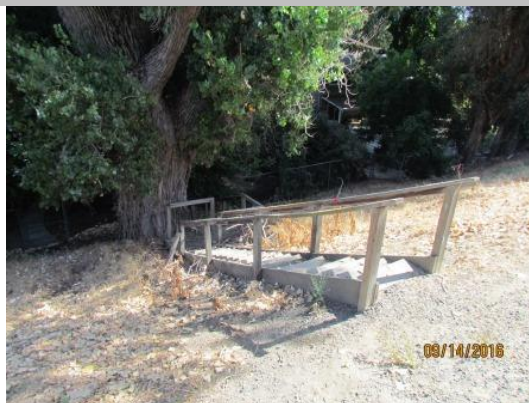
Photo 1 of 1 : SP_2018_MA0009_201_240_20180306_00186.jpg

LM Start	1.55	Rating **	M	Issue No.	240
LM End	1.55	Issue Type +	En	Location *	LS
Category	Earthen Levee			GPS Latitude/Longitude	
				Start	End
Item	Encroachments			38.525943 °	38.525943 °
				-121.527345 °	-121.527345 °
DWR ID	DWR_MA0009_01_f_2016_240				
Comment Code					
ST : Stairway					
Inspector Comment

Old wooden stairway on landside. Fall 2016 inspection.

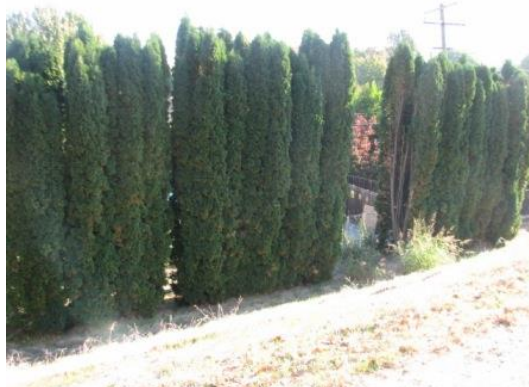
Photo 1 of 2 : SP_2018_MA0009_201_39_20180306_00026.jpg

LM Start	1.60	Rating **	M	Issue No.	39
LM End	1.62	Issue Type +	En	Location *	LS
Category	Earthen Levee			GPS Latitude/Longitude	
				Start	End
Item	Vegetation			38.525471 °	38.525368 °
				-121.526625 °	-121.526440 °
DWR ID	DWR_MA0009_01_s_2012_39				
Comment Code					
V6 : Landscaping					
Inspector Comment					
Cypress trees are blocking visibility on the landward side.

The tall hedge blocks visibility. Fall 2013

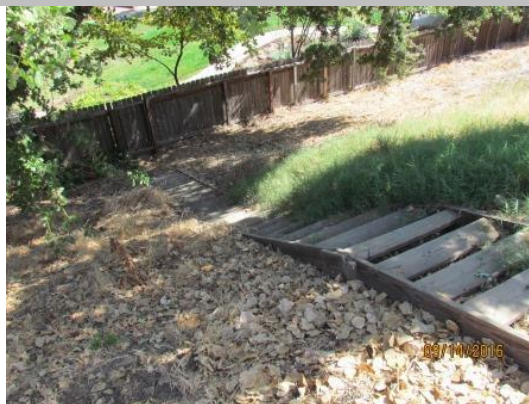
Photo 1 of 2 : SP_2018_MA0009_201_239_20180306_00184.jpg

LM Start	1.73	Rating **	M	Issue No.	239
LM End	1.73	Issue Type +	En	Location *	LS
Category	Earthen Levee			GPS Latitude/Longitude	
				Start	End
Item	Encroachments			38.524346 °	38.524346 °
				-121.524854 °	-121.524854 °
DWR ID	DWR_MA0009_01_f_2016_239				
Comment Code					
ST : Stairway					
Inspector Comment

Old wooden stairway on landside. Fall 2016 inspection.

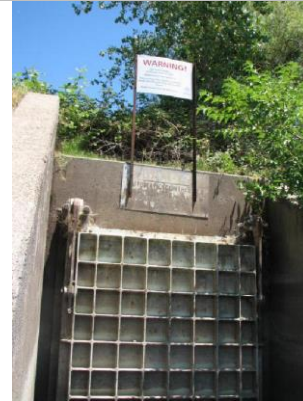
Photo 3 of 3 : UCIP_SP_2018_4703_6126.jpg

Comment Code						
Inspector Comment						
FS_ID:4703 DS_ID:17408 EP_NO: 5304A Repair Type: Non-Urgent Crossing Status: Found UCIP Comments: 06/06/2017 Received documentation from the City of Sacramento indicating that this crossing was internally inspected on 02/02/2012, PACP Sewer Report was provided. No additional information was received from the City of Sacramento. Need to request evaluation of pipe (integrity of pipe section through the levee) and find out when the City is planning the next internal inspection for this pipe. (DWR UCIP - O. Magana) 06/19/2012 Concrete around outlet broken up on both downstream and upstream side of outlet. Needs some repairs to prevent further damage. (DWR UCIP - W. Wylie) FIELD_STRUCT_DESC: [Sump No. 140] 8-foot by 8-foot reinforced concrete box drainage culvert through the levee, 28.9 feet below the crown. Pumps are located at the 35th Avenue sewage treatment plant. Concrete gate riser box is located on the waterside (WS) shoulder. Concrete headwall and flap gate on the WS end. (108-inch pipe authorized under Permit No. 5304, 1966 - City of Sacramento). [Additional Reference(s): DWR Levee Log, 1991. USACE Sacramento O&M Manual Unit 115, East Levee of Sacramento River From Sutterville Road to North Boundary of Reclamation District No. 744, February 1955, (Station 290+90, 78-inch diam steel pipe)] FS Date: 6/19/2012 2:20:32 PM

Flap Gate

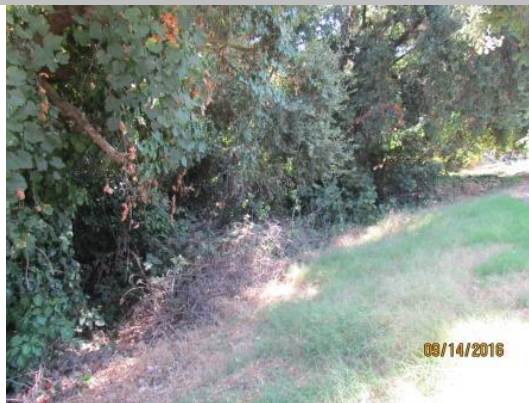
Photo 1 of 2 : SP_2018_MA0009_201_41_20180306_00029.jpg

LM Start	1.87	Rating **	M	Issue No.	41
LM End	1.90	Issue Type +	En	Location *	LS
Category	Earthen Levee			GPS Latitude/Longitude	
				Start	End
Item	Vegetation			38.522864 °	38.522507 °
				-121.523062 °	-121.522667 °
DWR ID	DWR_MA0009_01_s_2012_41				
Comment Code					
V6 : Landscaping					
Inspector Comment					
Trees need to be thinned and trimmed for visibility.

Trees on landward side of the levee. Lack of visibility. Fall 2016 inspection.

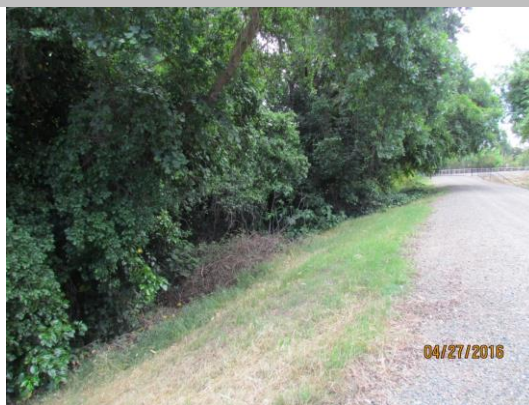
Photo 2 of 2 : SP_2018_MA0009_201_41_20180306_00030.jpg

LM Start	1.87	Rating **	M	Issue No.	41 (cont)
LM End	1.90	Issue Type +	En	Location *	LS

View of the trees blocking visibility on the landward side looking downstream. Spring 2016.

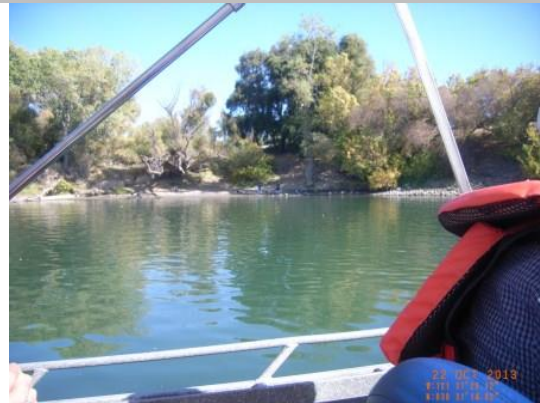
Photo 1 of 1 : SP_2018_MA0009_201_17_20180306_00015.jpg

LM Start	2.02	Rating **	M	Issue No.	17
LM End	2.05	Issue Type +	Ma	Location *	WS
Category	Supplemental			GPS Latitude/Longitude	
				Start	End
Item	2015 USACE Erosion Survey, DRAFT			38.520996 °	38.520606 °
				-121.523072 °	-121.523261 °
DWR ID	DWR_MA0009_01_s_2016_17				
Comment Code					
Inspector Comment					
2011 - Erosion into upper and lower slope. There has been significant scour around the tree roots. 2015: No observed changes. [2015 Site ID: SAC_53-8_L]

USACE 2013 Photo #1

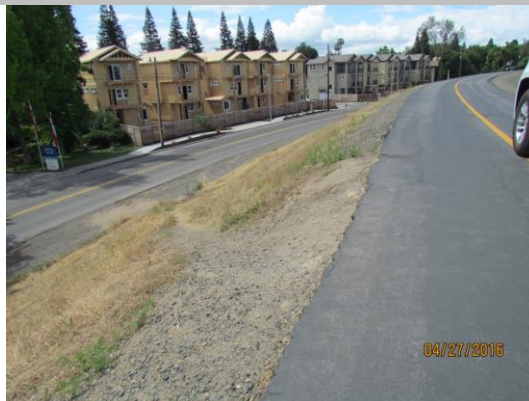
Photo 1 of 1 : SP_2018_MA0009_201_313_20180306_00249.jpg

LM Start	2.18	Rating **	A/W	Issue No.	313
LM End	2.18	Issue Type +	Ma	Location *	LS
Category	Earthen Levee			GPS Latitude/Longitude	
				Start	End
Item	Slope Stability			38.518878 °	38.518878 °
				-121.524288 °	-121.524288 °
DWR ID	DWR_MA0009_01_s _ 2016_313				
Comment Code					
S2 : Repair the levee slope damaged by foot traffic and prevent access where possible.					
Inspector Comment

View of the slope stability on the landward side of the levee looking downstream. Spring 2016.

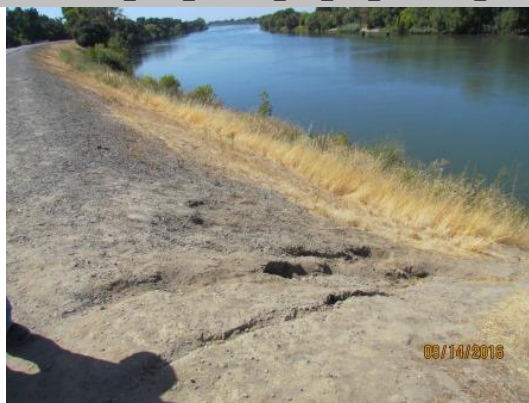
Photo 1 of 1 : SP_2018_MA0009_201_243_20180306_00190.jpg

LM Start	2.28	Rating **	M	Issue No.	243
LM End	2.28	Issue Type +	Ma	Location *	WS
Category	Earthen Levee			GPS Latitude/Longitude	
				Start	End
Item	Erosion / Bank Caving			38.517942 °	38.517942 °
				-121.525612 °	-121.525612 °
DWR ID	DWR_MA0009_01_f_2016_243				
Comment Code					
E2 : Schedule repair of erosion site prior to the next inspection.					
Inspector Comment					
Erosion from runoff.

View of erosion site on waterward slope of the levee. Fall 2016 inspection.

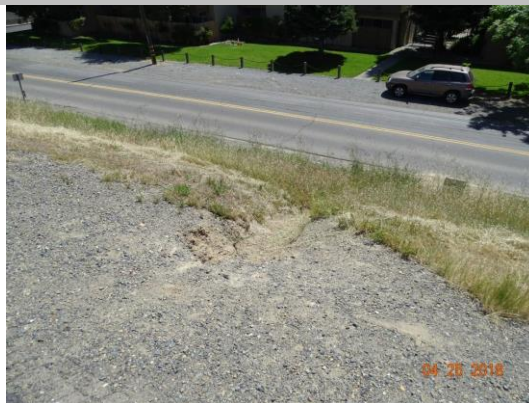
Photo 1 of 2 : SP_2018_MA0009_201_244_20180425_00521.jpg

LM Start	2.30	Rating **	M	Issue No.	244
LM End	2.30	Issue Type +	Ma	Location *	LS
Category	Earthen Levee			GPS Latitude/Longitude	
				Start	End
Item	Slope Stability			38.517755 °	38.517755 °
				-121.525941 °	-121.525941 °
DWR ID	DWR_MA0009_01_f_2016_244				
Comment Code					
S2 : Repair the levee slope damaged by foot traffic and prevent access where possible.					
Inspector Comment

Updated view of foot path on the landside slope. Spring 2018.

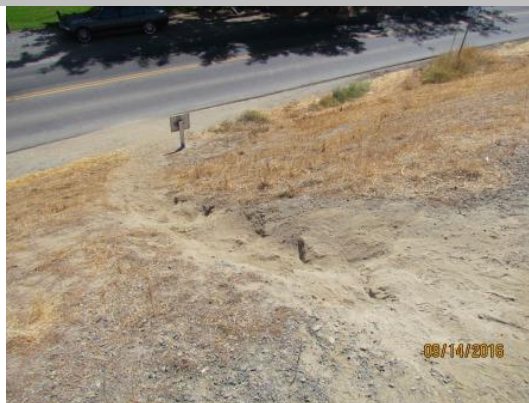
Photo 2 of 2 : SP_2018_MA0009_201_244_20180306_00191.jpg

LM Start	2.30	Rating **	M	Issue No.	244 (cont)
LM End	2.30	Issue Type +	Ma	Location *	LS

Foot path on landside slope of the levee. Fall 2016 inspection.

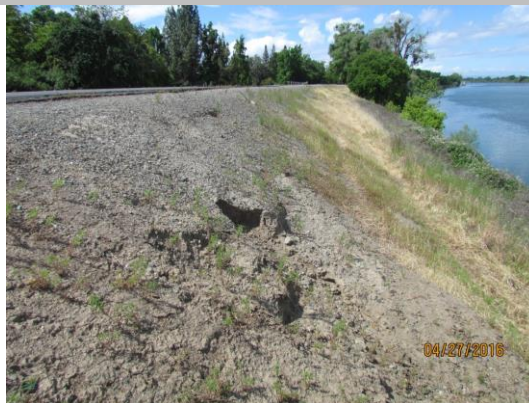
Photo 1 of 1 : SP_2018_MA0009_201_322_20180306_00255.jpg

LM Start	2.33	Rating **	A/W	Issue No.	322
LM End	2.33	Issue Type +	Ma	Location *	WS
Category	Earthen Levee			GPS Latitude/Longitude	
				Start	End
Item	Slope Stability			38.517526 °	38.517526 °
				-121.526431 °	-121.526431 °
DWR ID	DWR_MA0009_01_f_2015_322				
Comment Code					
S2 : Repair the levee slope damaged by foot traffic and prevent access where possible.					
Inspector Comment

View of the slope stability on the waterward side of the levee looking downstream. Spring 2016.

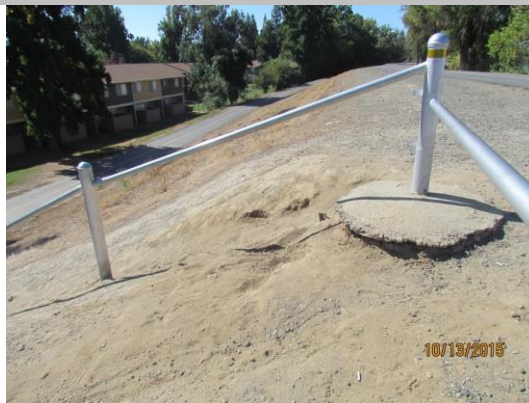
Photo 1 of 2 : SP_2018_MA0009_201_323_20180306_00256.jpg

LM Start	2.40	Rating **	M	Issue No.	323
LM End	2.40	Issue Type +	Ma	Location *	LS
Category	Earthen Levee			GPS Latitude/Longitude	
				Start	End
Item	Slope Stability			38.517131 °	38.517131 °
				-121.527568 °	-121.527568 °
DWR ID	DWR_MA0009_01_f_2015_323				
Comment Code					
S2 : Repair the levee slope damaged by foot traffic and prevent access where possible.					
Inspector Comment

View of the the slope stability on the landward side of the levee looking downstream. Fall 2015.

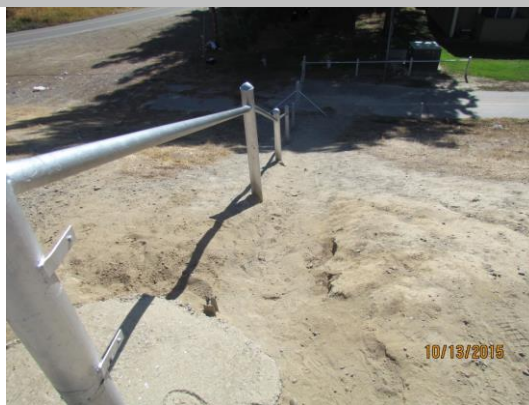
Photo 2 of 2 : SP_2018_MA0009_201_323_20180306_00257.jpg

Additional view of slope stability. Fall 2015.

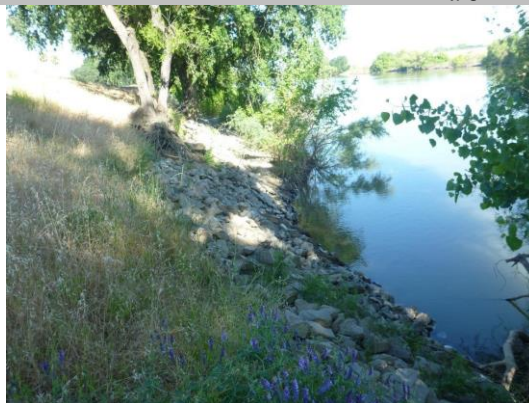
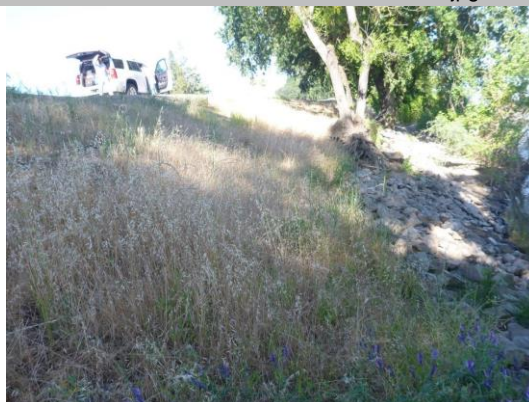
LM Start	2.51	Rating **	A/W	Issue No.	230
LM End	2.52	Issue Type +	Ma	Location *	
Category	Supplemental			GPS Latitude/Longitude	
				Start	End
Item	2017 Storm Damage			38.516660 °	38.516653 °
				-121.529538 °	-121.529645 °
DWR ID	DWR_MA0009_01_f_2017_230				
Comment Code					
Inspector Comment					
Levee Evaluation Comments					
Description:					
Site ID No:230					
Site Designation:LMA-63					
Repair Type: Erosion					
Rating:Area of Concern					
Field Date:2/10/2017					
Notes: Oversized section of levee with rip rap on the waterside slope.					
Little damage visible.

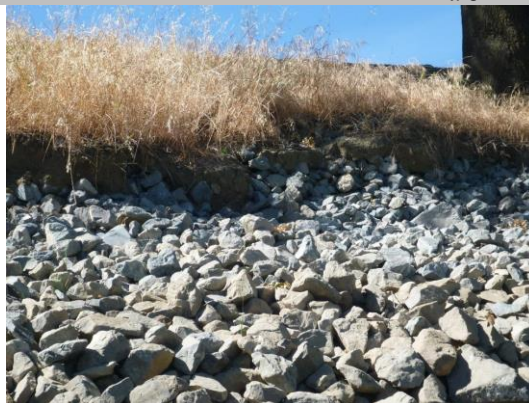
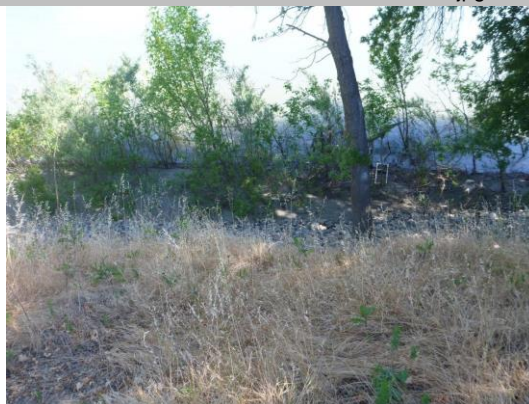
LM Start	2.57	Rating **	A/W	Issue No.	231 (cont)
LM End	2.58	Issue Type +	Ma	Location *	
Category	Supplemental			GPS Latitude/Longitude	
				Start	End
Item	2017 Storm Damage			38.516444 °	38.516442 °
				-121.530639 °	-121.530677 °
DWR ID	DWR_MA0009_01_f _ 2017_231				
Comment Code					
Inspector Comment					
Levee Evaluation Comments					
Description:					
Site ID No:231					
Site Designation:LMA-64					
Repair Type: Erosion					
Rating:Area of Concern					
Field Date:6/2/2017					
Notes: The crown of this levee is well over 60 feet, and newly placed riprap is on the waterside slope. Minor damage visible.

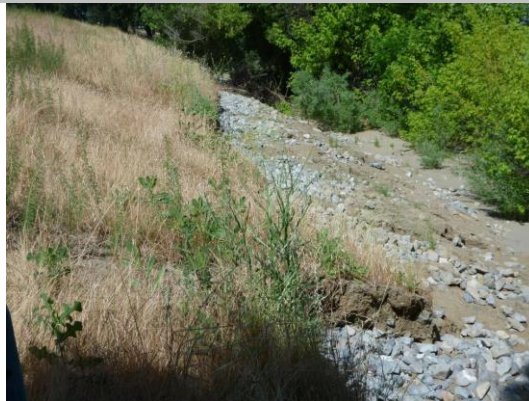
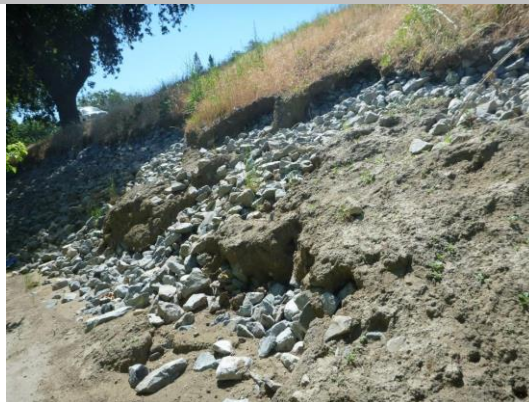
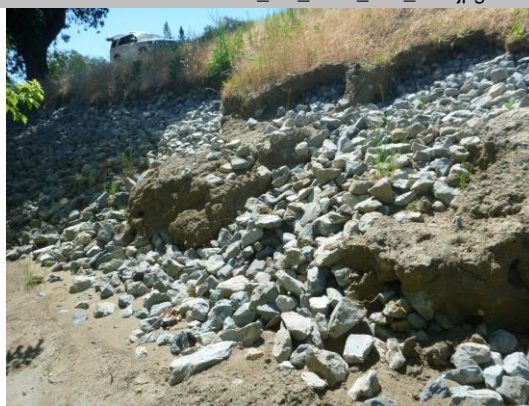
LM Start	2.57	Rating **	A/W	Issue No.	232
LM End	2.58	Issue Type +	Ma	Location *	
Category	Supplemental			GPS Latitude/Longitude	
				Start	End
Item	2017 Storm Damage			38.516444 °	38.516442 °
				-121.530639 °	-121.530677 °
DWR ID	DWR_MA0009_01_f_2017_232				
Comment Code					
Inspector Comment					
Levee Evaluation Comments					
Description:					
Site ID No:232					
Site Designation:LMA-65					
Repair Type: Erosion					
Rating:Area of Concern					
Field Date:6/2/2017					
Notes: riparian scrub vegetation along WS bank/bech

LM Start	2.57	Rating **	A/W	Issue No.	232 (cont)	
LM End	2.58	Issue Type +	Ma	Location *		
Category	Supplemental			GPS Latitude/Longitude		
				Start		End
Item	2017 Storm Damage			38.516444 °	38.516442 °	
				-121.530639 °	-121.530677 °	
DWR ID	DWR_MA0009_01_f_2017_232					
Comment Code						
Inspector Comment						
Levee Evaluation Comments						
Description:						
Site ID No:232						
Site Designation:LMA-65						
Repair Type: Erosion						
Rating:Area of Concern						
Field Date:6/2/2017						
Notes: riparian scrub vegetation along WS bank/bech

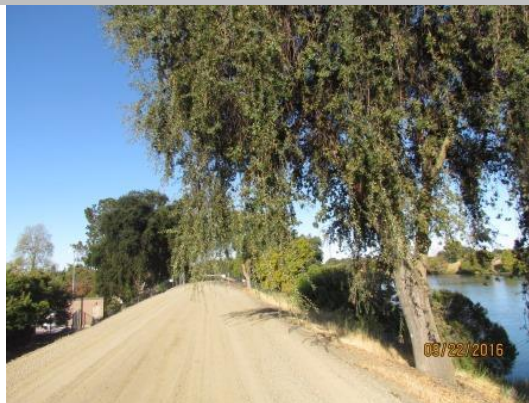
Photo 1 of 1 : SP_2018_MA0009_201_245_20180306_00192.jpg

LM Start	2.72	Rating **	A/W	Issue No.	245
LM End	2.72	Issue Type +	Ma	Location *	CR
Category	Earthen Levee			GPS Latitude/Longitude	
				Start	End
Item	Trim / Thin Trees			38.516271 °	38.516271 °
				-121.533288 °	-121.533288 °
DWR ID	DWR_MA0009_01_f_2016_245				
Comment Code					
T4 : Trim trees over roadway to at least 12 feet above ground level.					
Inspector Comment

View of a tree on WS slope looking downstream. Fall 2016.

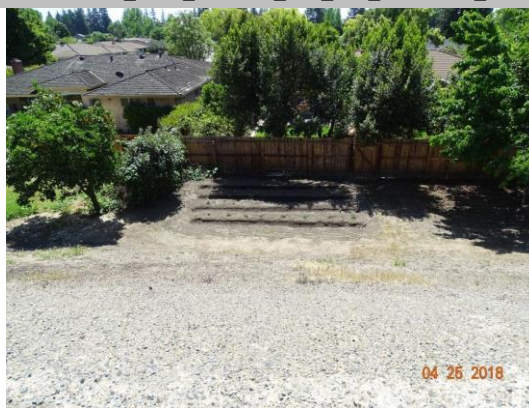
Photo 1 of 1 : SP_2018_MA0009_201_235_20180425_00522.jpg

LM Start	2.73	Rating **	M	Issue No.	235
LM End	2.73	Issue Type +	En	Location *	LS
Category	Earthen Levee			GPS Latitude/Longitude	
				Start	End
Item	Vegetation			38.516236 °	38.516236 °
				-121.533581 °	-121.533581 °
DWR ID	DWR_MA0009_01_s_2018_235				
Comment Code					
V6 : Landscaping					
Inspector Comment					
Landowner has dug rows for a garden within 10' of the landside toe.

View of garden rows near landside toe. Spring 2018.

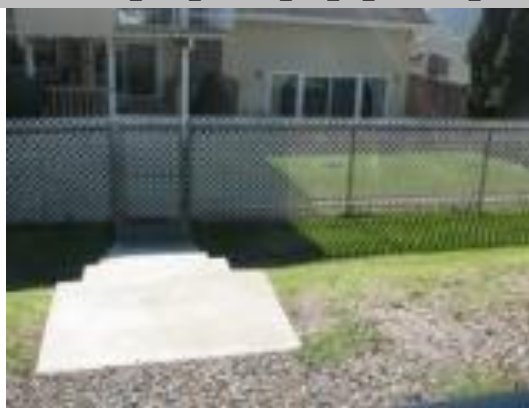
Photo 1 of 1 : SP_2018_MA0009_201_51_20180306_00032.jpg

LM Start	2.94	Rating **	M	Issue No.	51
LM End	2.94	Issue Type +	En	Location *	LS
Category	Earthen Levee			GPS Latitude/Longitude	
				Start	End
Item	Encroachments			38.516025 °	38.516025 °
				-121.537391 °	-121.537391 °
DWR ID	DWR_MA0009_01_s_2017_51				
Comment Code					
ST : Stairway					
Inspector Comment

Steps and landscaping in easement. Fall 2012

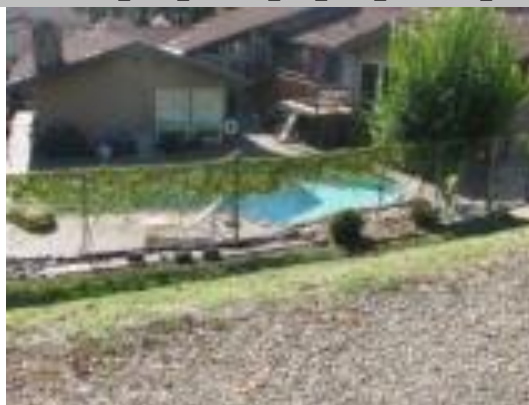
Photo 1 of 1 : SP_2018_MA0009_201_1254_20180306_00321.jpg

LM Start	2.97	Rating **	M	Issue No.	1254
LM End	2.97	Issue Type +	En	Location *	LS
Category	Earthen Levee			GPS Latitude/Longitude	
				Start	End
Item	Encroachments			38.515971 °	38.515971 °
				-121.537862 °	-121.537862 °
DWR ID	DWR_MA0009_01_s_2012_1254				
Comment Code					
PL : Pool					
Inspector Comment					
Pool is still there with retaining wall.

Pool and retaining wall in the easement. Fall 2012

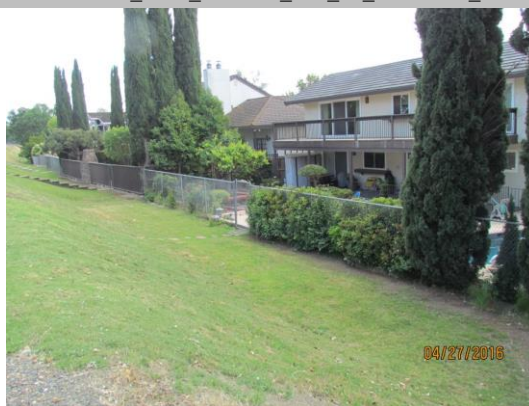
Photo 1 of 1 : SP_2018_MA0009_201_54_20180306_00033.jpg

LM Start	2.97	Rating **	M	Issue No.	54
LM End	2.97	Issue Type +	En	Location *	LS
Category	Earthen Levee			GPS Latitude/Longitude	
				Start	End
Item	Vegetation			38.515954 °	38.515954 °
				-121.537966 °	-121.537966 °
DWR ID	DWR_MA0009_01_s_2012_54				
Comment Code					
V6 : Landscaping					
Inspector Comment					
Bushes and trees block visibility at the toe of the levee.

View of the landscaping planted at the toe of the levee on the landward side looking upstream. Spring 2016.

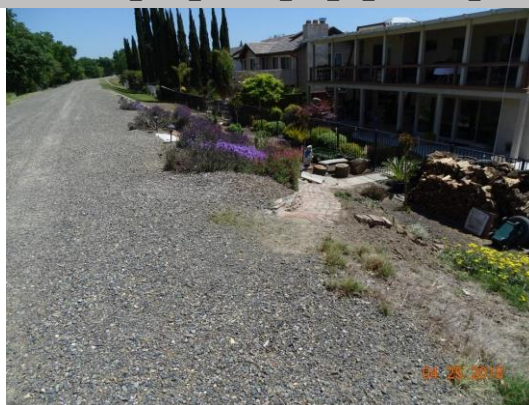
Photo 1 of 1 : SP_2018_MA0009_201_35_20180425_00523.jpg

LM Start	3.01	Rating **	M	Issue No.	35
LM End	3.02	Issue Type +	En	Location *	LS
Category	Earthen Levee			GPS Latitude/Longitude	
				Start	End
Item	Vegetation			38.515860 °	38.515821 °
				-121.538635 °	-121.538895 °
DWR ID	DWR_MA0009_01_f_2017_35				
Comment Code					
V6 : Landscaping					
Inspector Comment					
Footpath and multiple planter boxes at landside toe.

View of vegetation and footpath on the landside slope. Spring 2018.

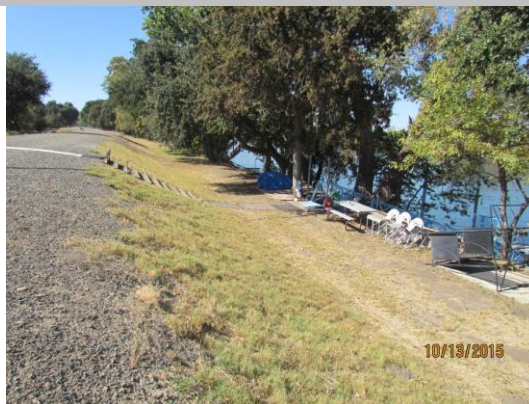
Photo 1 of 1 : SP_2018_MA0009_201_1768_20180306_00322.jpg

LM Start	3.01	Rating **	M	Issue No.	1768
LM End	3.01	Issue Type +	En	Location *	LS
Category	Earthen Levee			GPS Latitude/Longitude	
				Start	End
Item	Encroachments			38.515841 °	38.515841 °
				-121.538710 °	-121.538710 °
DWR ID	DWR_MA0009_01_s_2017_1768				
Comment Code					
FW : Firewood					
Inspector Comment

View of the equipment on the berm of the waterward side looking downstream. Fall 2015.

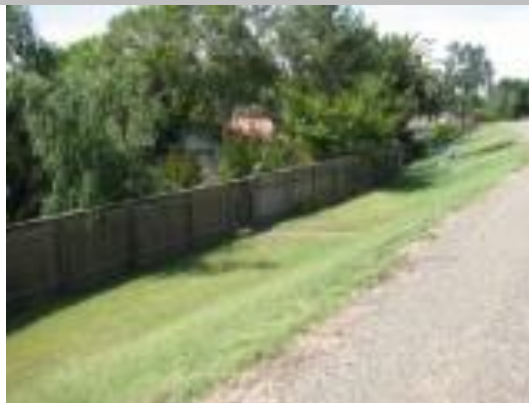
Photo 1 of 1 : SP_2018_MA0009_201_58_20180306_00035.jpg

LM Start	3.03	Rating **	M	Issue No.	58
LM End	3.08	Issue Type +	En	Location *	LS
Category	Earthen Levee			GPS Latitude/Longitude	
				Start	End
Item	Encroachments			38.515811 °	38.515598 °
				-121.538988 °	-121.539976 °
DWR ID	DWR_MA0009_01_s_2012_58				
Comment Code					
FE : Fence					
Inspector Comment

Several homes have solid fences and make it hard to see.
